INSPECTION REPORT

Report ID: (R-060616-03

1821 Hartford Rolla. MO 65401

6/6/2016 - 08:45 AM

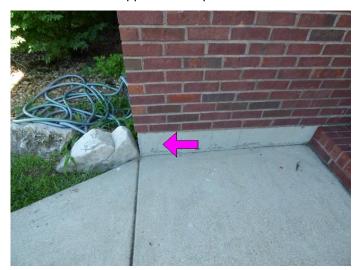
- (1) **COMMENT**: The visible portions of the foundation walls were in satisfactory condition at the time of the inspection.
- (2) **COMMENT**: One exterior corner of the concrete foundation wall was cracked. Stresses due to expansion of the brick veneer during hot weather combined with an improper bond breaker between the brick and the top of the foundation causes this type of cracking. These cracks are typically small and considered a cosmetic issue, unless more than 50% of the brick above is unsupported. The foundation was adequately supporting the brick veneer at the time of the inspection.

13.0 Picture 1 - Foundation corner crack

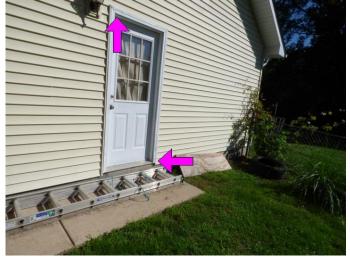
REPAIR AS NEEDED: The side garage door has moisture damaged brick molding and door jambs. Further deterioration may occur if not repaired. A qualified contractor should inspect and repair as needed. (**See Picture 4**, **Appendix A**)

13.0 Picture 4 - The door jamb/trim has moisture damage

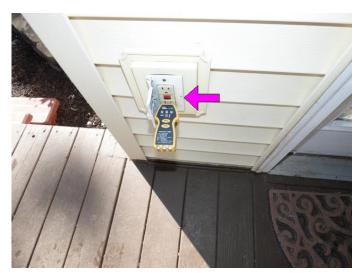
SAFETY: The GFCI protected receptacles worked, except the outlet at the rear deck failed to respond properly when tested using the built-in test button and needs to be replaced. (See Picture 5, Appendix A)

Note: Due to rain and high humidity many older exterior GFCI outlets fail to trip when the test button is pushed. Manufacturers now make GFCI outlets rated for outdoor use.

13.0 Picture 5 - Exterior GFCI outlet defective

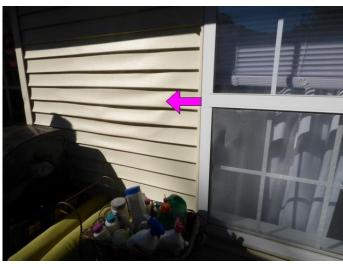
COMMENT: The vinyl siding and brick veneer were in satisfactory condition, except for a heat warped section behind the BBQ grill. (See Picture 6, Appendix A)

13.0 Picture 6 - Heat warped from BBQ grill

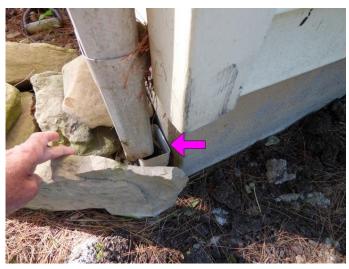
MAINTENANCE: The ground drain-line has settled and pulled loose from downspout on the right corner (facing rear) and needs to be re-connected. This is a maintenance item for your consideration. (See Picture 7, Appendix A)

13.0 Picture 7 - Downspout disconnected

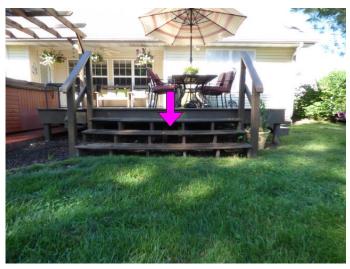
13.0 Picture 8 - Steps sag in the center

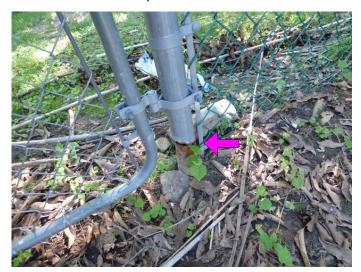
REPAIR AS NEEDED: The fencing and gates on the property appeared functional, however at least two posts were rusted through. I recommend a qualified person replace the damaged posts. (See Picture 9, 10, Appendix A)

13.0 Picture 9 - Gate post rusted through

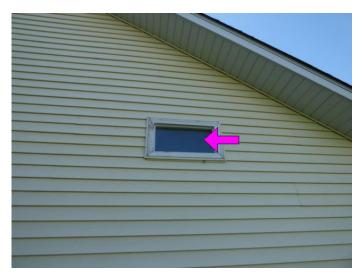
(2) **REPAIR AS NEEDED:** The thermal window units at the front bedroom and hall bath have lost their thermal seal, with condensation or stains noted between the glass panes. The functional characteristics of a window displaying condensation between panes is generally limited to some reduction in the ability to see through the window and loss of insulating value of the window unit. A qualified person should repair or replace as needed. (See Pictures 3, 11, Appendix A)

13.0 Picture 11 - Thermal seal broke

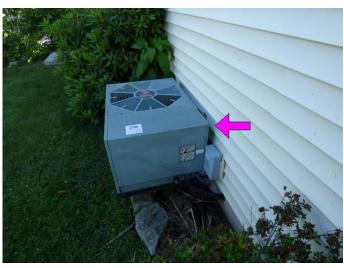
- (1) **COMMENT**: The central cooling system located in the hallway responded to normal user controls at the time of the inspection.
- (2) **MAINTENANCE**: The outdoor condenser unit does not have the minimum 6" clearance most manufacturers recommend. Proper air flow is recommended for efficiency. I recommend a qualified HVAC contractor look at this unit to see if it needs to be further away from the building. (See Picture 12, Appendix A)

13.0 Picture 12 - Inadequate clearance

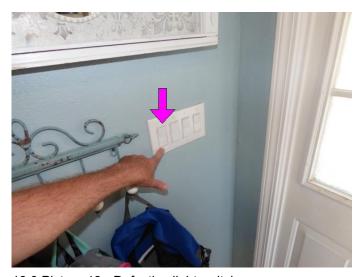
MAINTENANCE: All tested electric lights, outlets and fixtures were found to be in satisfactory condition at the time of the inspection, except the entry way light switch appears defective. This is a maintenance item for your consideration. (See Picture 13, Appendix A)

13.0 Picture 13 - Defective light switch

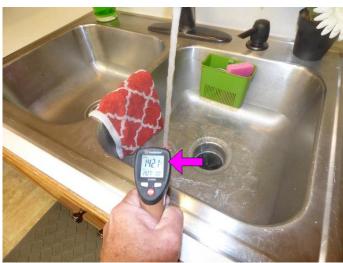
(2) **SAFETY**: Hot water temperature was 142.1 degrees and could seriously burn an infant or young child should they come into contact with the hot water. Temperatures 140 degrees and above can cause serious burns in only a few seconds. I recommend you turn the hot water heater down to 120 degrees or less. (**See Picture 14, Appendix A**)

13.0 Picture 14 - Hot water 142.1 degrees

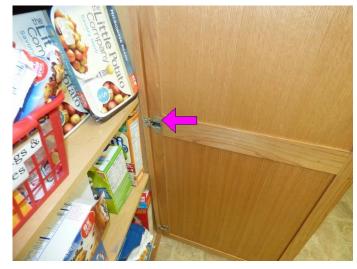
13.0 Picture 15 - Loose hinges

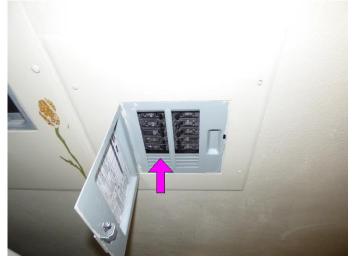
SAFETY: The main panel and its components have no visible deficiencies, however the subpanel was not installed flush with the drywall, which leaves a gap between the dead front panel and the bottom breakers. I recommend covering the open gap with tape to prevent a child from sticking their fingers through the gap. (See Picture 16, Appendix A)

13.0 Picture 16 - Subpanel not flush with wall

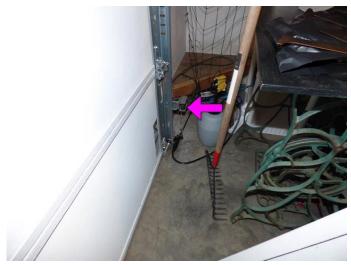
13.0 Picture 17 - Door sensor too high

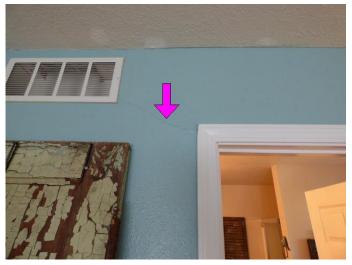
COMMENT: The wall coverings, where visible, were in satisfactory condition for their age, however there was a wall crack at the master bathroom door. (See Picture 19, Appendix A)

13.0 Picture 19 - Wall crack

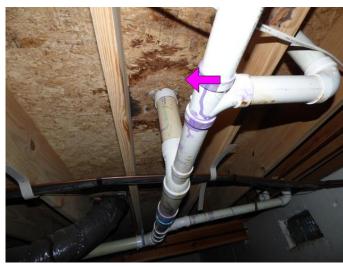
COMMENT: Where visible, the subfloor structure components appeared functional, however old water stains from a past toilet leak were visible. (See Picture 20, Appendix A)

13.0 Picture 20 - Toilet leaked in the past

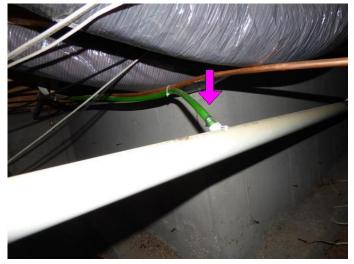
SAFETY: The water softener drain line connects directly to the sewer drain line and is not equipped with an air gap device, which can lead to contamination of the water supply and should be corrected. I recommend a qualified plumber make the necessary modifications. This is a health safety item for your consideration. (**See Picture 22, Appendix A**)

13.0 Picture 22 - Water softener drain connected to sewer pipe
