Report Prepared For:

**Property Address:**xxxx Old St. James Road
Rolla, MO 65401**INSPECTION CERTIFICATION**

GENERAL INFORMATION

xxxx Old St. James Road
 Rolla MO 65401

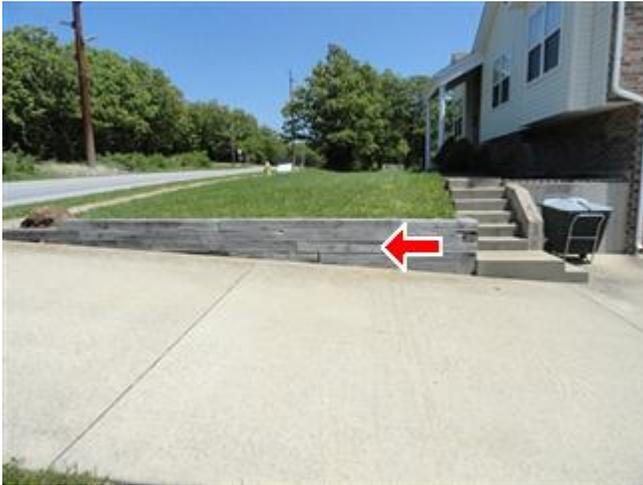
The timber retaining wall was sounded revealing a few rotten spots. Sounding a solid timber has a clear ring when tapped with a small hammer but you will hear a dull thump if you tap a rotted timber in the same way. Eventually some or all of these timbers will need replacement. This is a maintenance issue for your consideration. **(See Picture 1, Appendix A)**

13.0 Picture 1 - Retaining wall

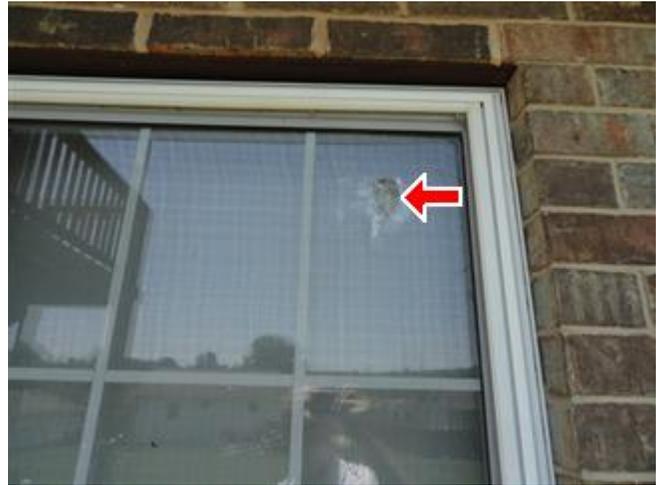
The screen on the basement window located at the lower right when facing the back of the house is damaged. This is a maintenance issue for your consideration. **(See Picture 2, Appendix A)**

13.0 Picture 2 - Screen damaged at back of house

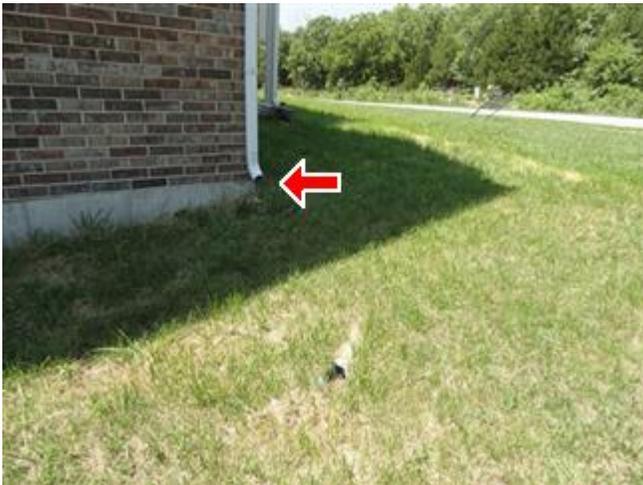
The discharge point for one or more downspouts was observed to be near the foundation wall. Water discharge should be as far from the foundation wall as practical to prevent soil erosion and water saturation near the foundation. Downspouts are a key component in the controlling roof drainage away from the home's exterior foundation. If the surrounding soil slopes away from the foundation installing downspout extensions would be sufficient. In low areas or areas where the soil slopes toward the foundation gutter extensions will not work therefore piping the water underground may be a better solution. This is a maintenance issue for your consideration. **(See Picture 3, Appendix A)**

13.0 Picture 3 - Downspout discharges next to the foundation

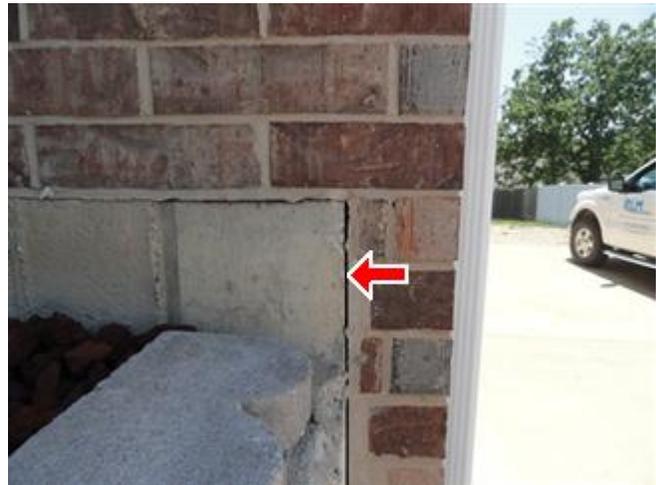
- The open joint near the right front corner of the house needs caulked to prevent water infiltration. **(See Picture 4, Appendix A)**
- There is a crack that starts at the center of the garage door and progresses upward for a few feet. This crack is the result of excessive deflection of the wall above the garage door. At the time of this inspection the deflection was approximately 1/2 inch. This issue is discussed in more detail in Section 4.2. **(See Pictures 18, 19, Appendix A)**

13.0 Picture 4 - Open joint needs caulked

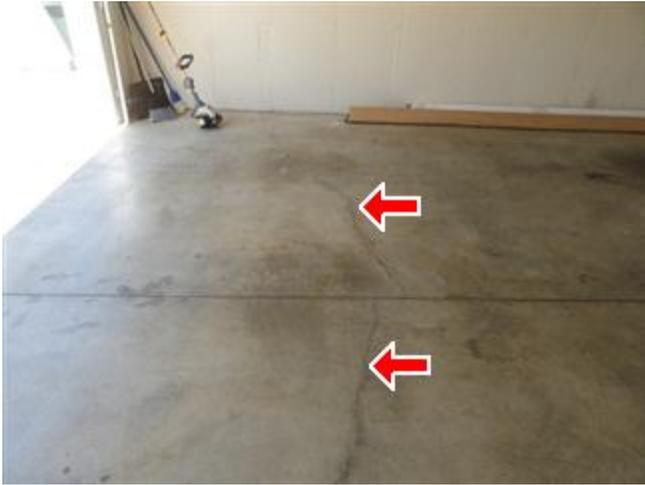
13.0 Picture 5 - Typical settlement/shrinkage cracks

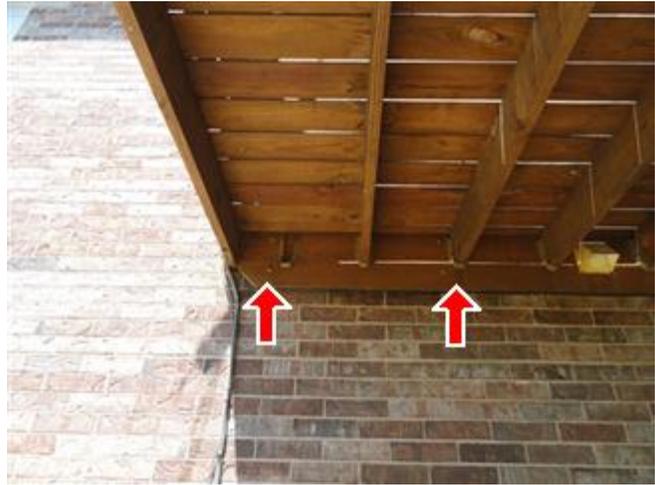
13.0 Picture 6 - Deck bolted to brick veneer

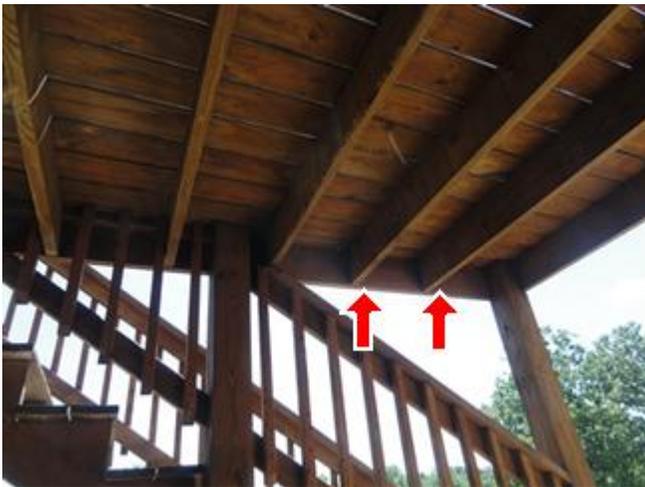
13.0 Picture 7 - Missing metal joist hangers

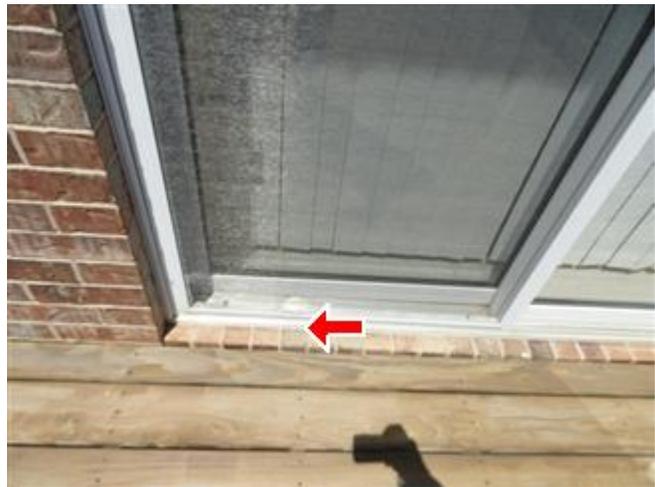
13.0 Picture 8 - Hole in patio door screen

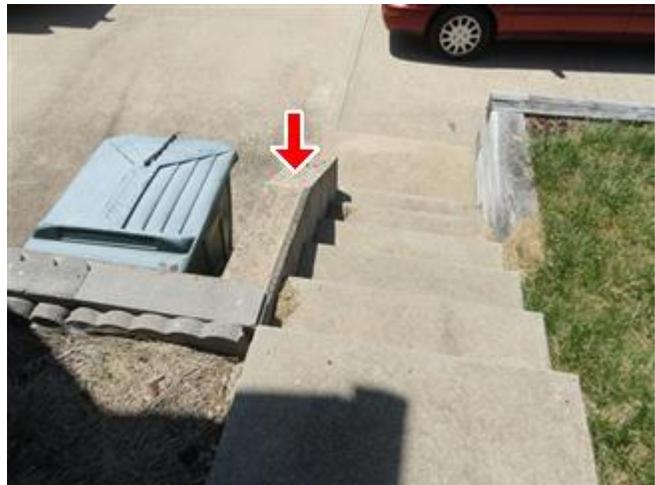
13.0 Picture 10 - No handrail on steps

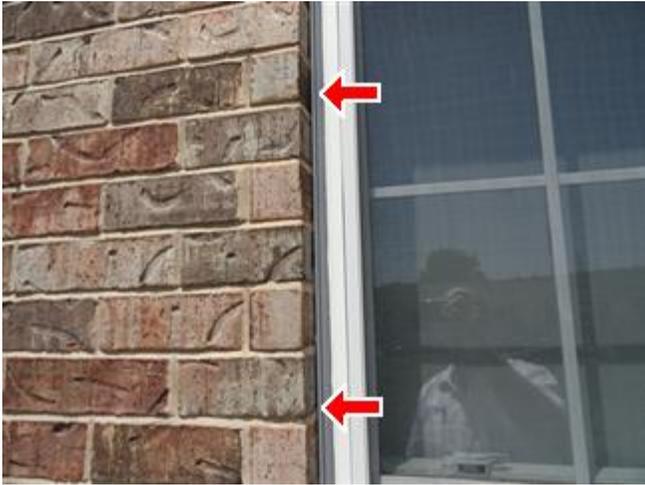
13.0 Picture 11 - Some windows need caulked

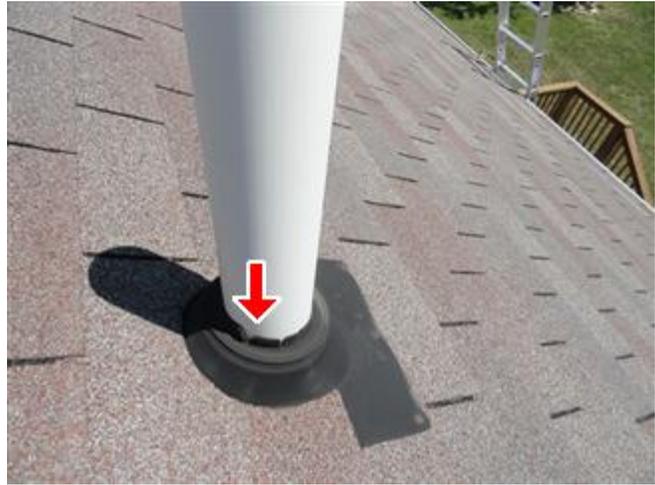
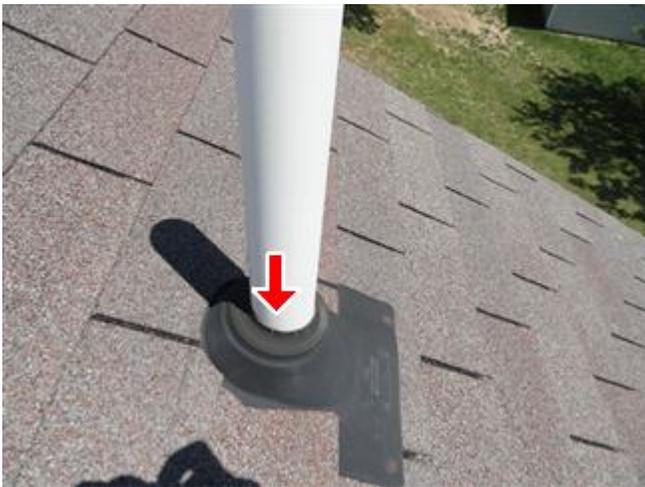
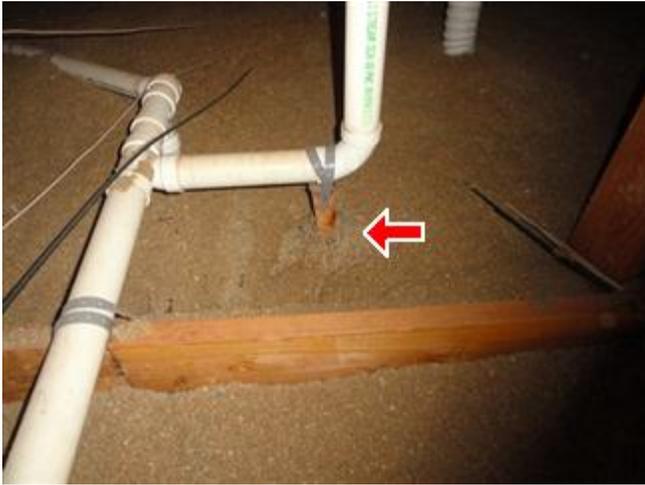
The rubber flange on the sewer vent pipes have failed. A qualified person should repair or replace as needed. **(See Pictures 12, 13, 35, 36 Appendix A)**

13.0 Picture 12 - Sewer vent boot needs replaced

13.0 Picture 13 - Sewer vent boot needs replaced

13.0 Picture 35 - Evidence of water leak at sewer vent pipe

13.0 Picture 36 - Daylight showing at sewer vent boot

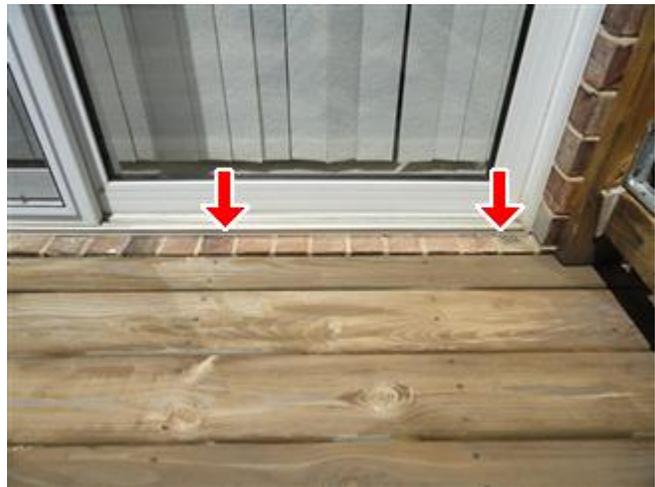
(2) The rear patio door needs caulking applied along the brick at the bottom. Water leaks around patio doors have caused significant damage to subflooring and wall materials on many of the houses we have inspected. This is a maintenance issue for your consideration. **(See Picture 14, Appendix A)**

13.0 Picture 14 - Caulking needed at bottom of patio door

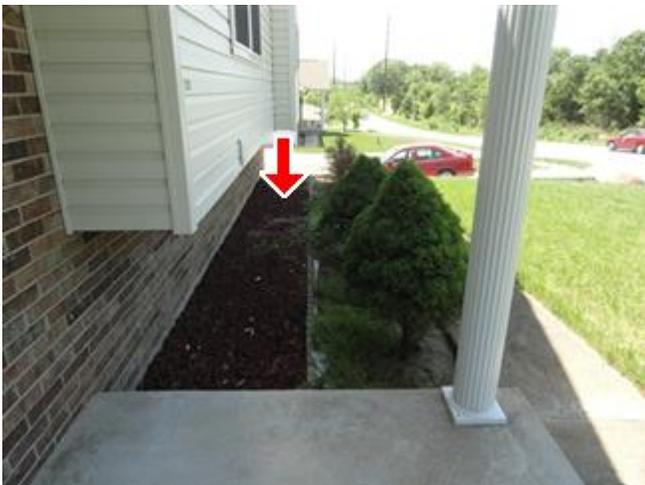
The area right of the front entrance between the sidewalk and house has no apparent method of draining rain water that falls within this area. This area will retain water and will seep into any foundation cracks. If you make any landscaping changes in this area I recommend adding some method of draining or diverting water. **(See Picture 15, Appendix A)**

13.0 Picture 15 - Area of poor drainage

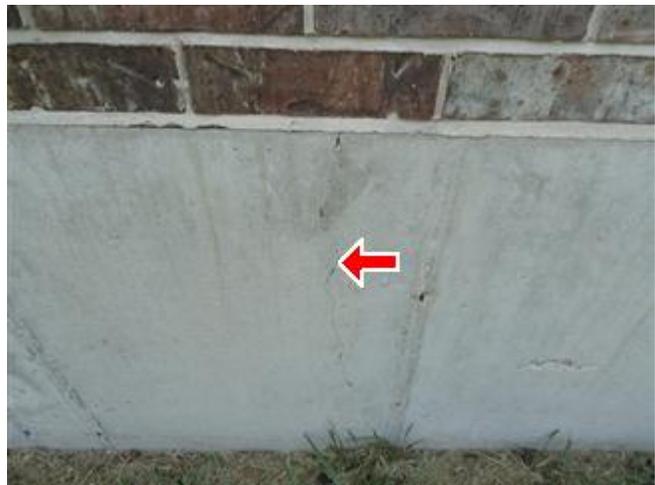
The foundation on this house has a few typical shrinkage cracks. **(See Picture 16, Appendix A)**

13.0 Picture 16 - Typical shrinkage crack

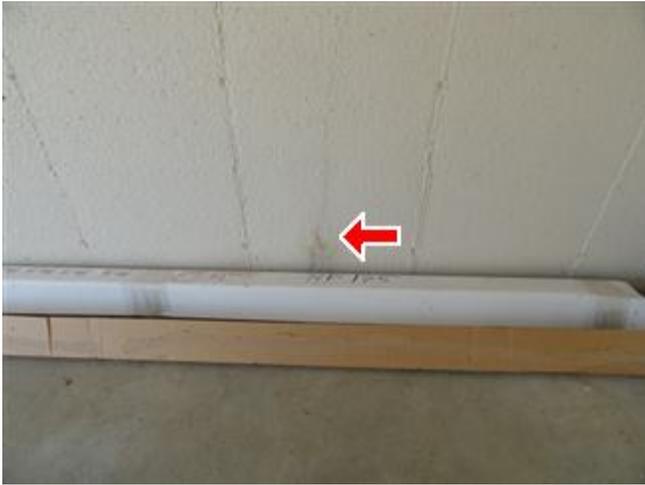
Note: There is a small foundation crack in the garage wall that has seeped water from this area. **(See Picture 17, Appendix A)**

13.0 Picture 17 - Water stains from seepage at wall crack

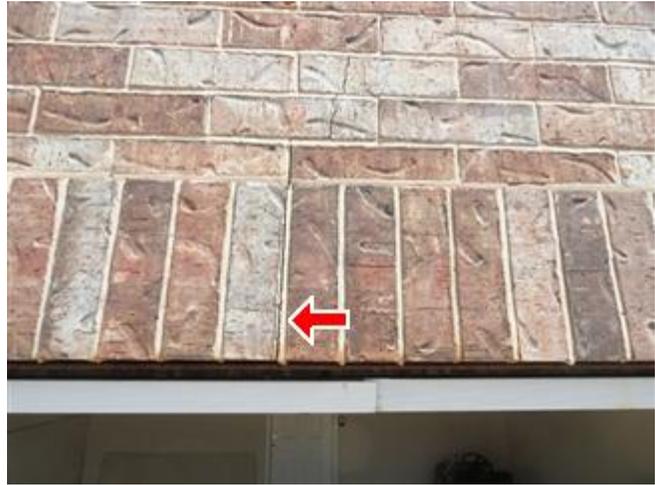
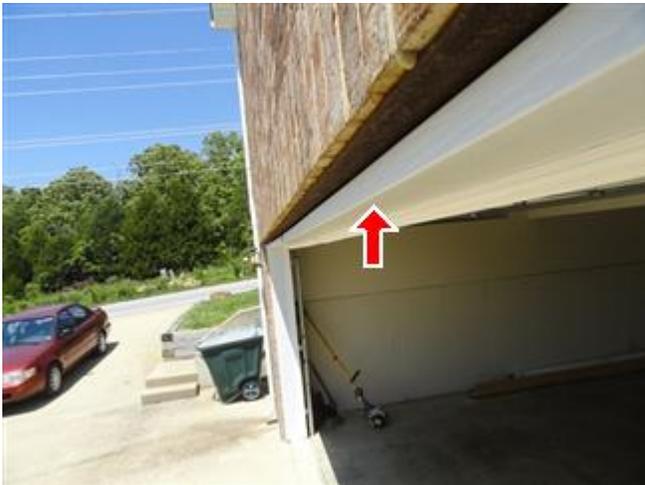
(3) The main support beam over the garage door has sagged approximately 1/2 inch causing a crack in the brick veneer and in some interior drywall. It appears the beam may be undersized for the load, however verification the beam size and material was not visible due to drywall. I recommend a more in-depth inspection requiring some drywall removal in order to verify the beams capacity. **(See Pictures 18, 19, Appendix A)**

13.0 Picture 18 - Brick cracked over garage door

13.0 Picture 19 - Wall/beam over garage door has sagged 1/2 inch

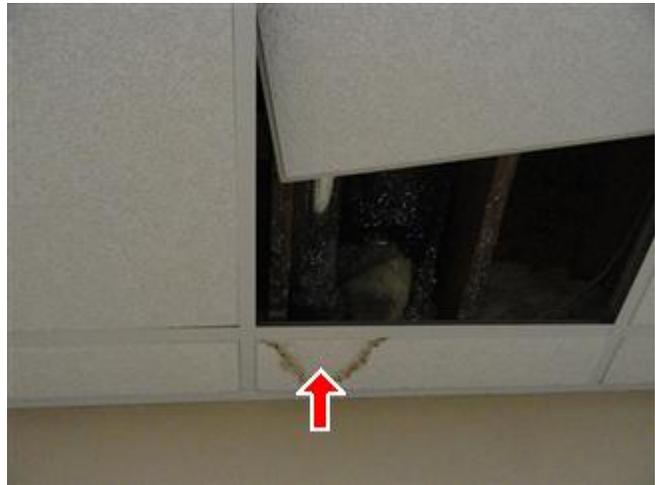
(1) There were multiple stains on the ceiling tiles in the basement. All stained tiles were moved and the source of the water was identified as one or more of the following:

- Water supply line leak
- Waste water drain line leak **(See Picture 27, Appendix A)**
- Toilet leak **(See Picture 26, Appendix A)**
- Condensation from dryer vent pipe **(See Picture 20, Appendix A)**

13.0 Picture 20 - Water stained tile from dryer vent condensation

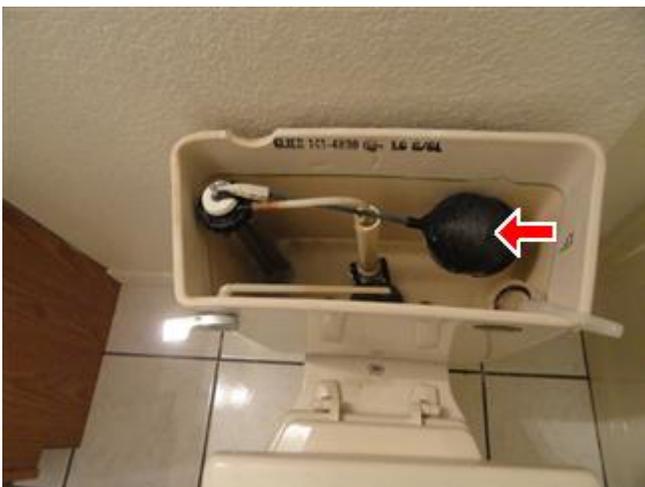
(2) The float in the basement toilet rubs on the tank and prevents the toilet from filling up properly. I recommend a qualified plumber repair or replace as needed. **(See Picture 21, Appendix A)**

13.0 Picture 21 - Float in basement toilet needs adjusted

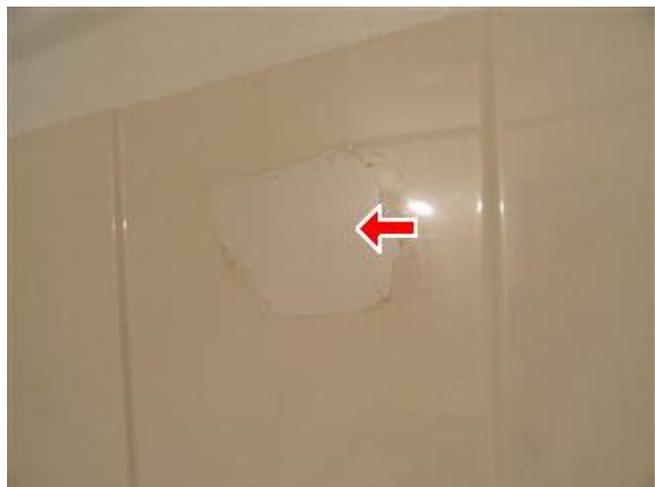
13.0 Picture 22 - Appears to be a sticker on the tub surface

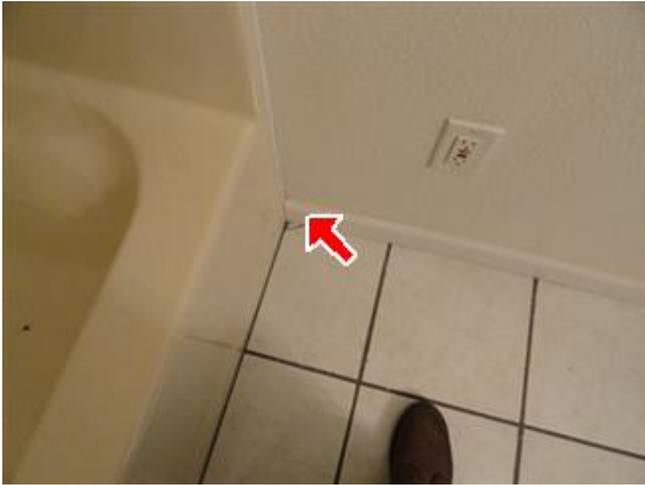
(1) There was a small corner broken on the floor tile in the basement bathroom. This is a maintenance issue for your consideration. **(See Picture 23, Appendix A)**

13.0 Picture 23 - Small tile crack

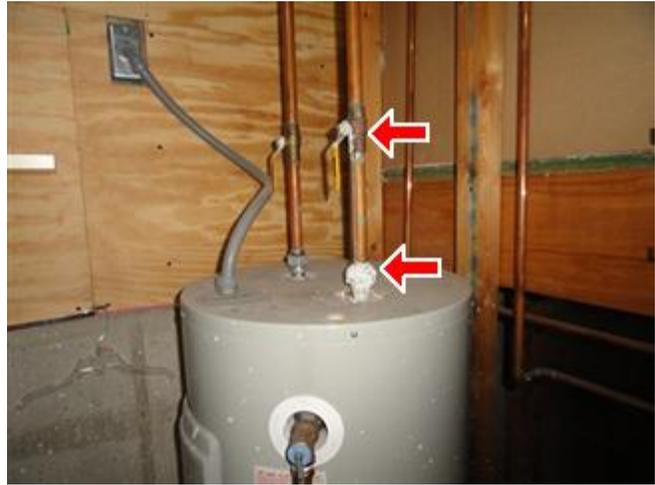
The supply line to the water heater has some corrosion visible at the valve and at the dielectric union from past water leaks. These areas were dry at the time of this inspection but should be monitored. This is a maintenance issue for your consideration. **(See Picture 24, Appendix A)**

13.0 Picture 24 - Evidence of past leaks

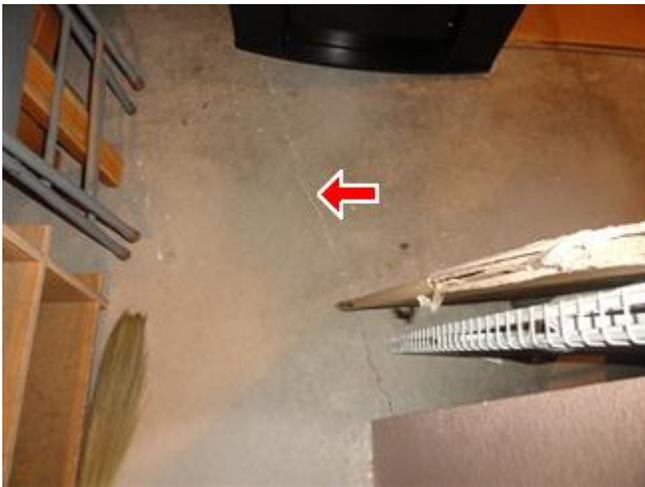
(2) Where visible, the basement floor appeared in good condition with one noticeable crack found in the room where the electrical panel is located. I recommend caulking this crack and monitor for further movement. **(See Picture 25, Appendix A)**

13.0 Picture 25 - Basement floor crack

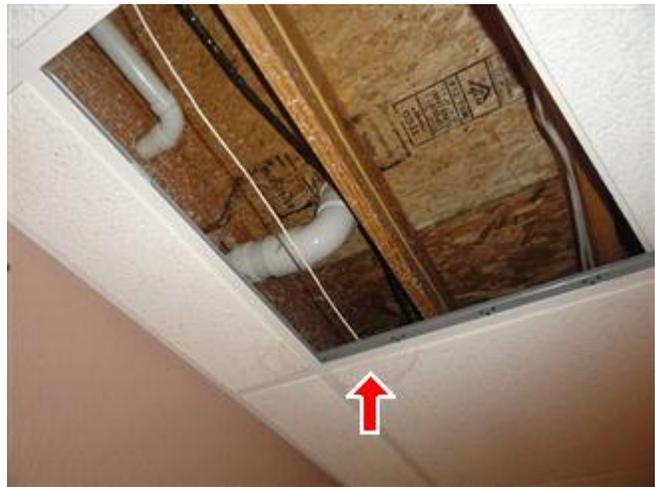
13.0 Picture 26 - Water stained tile from master bath toilet leak

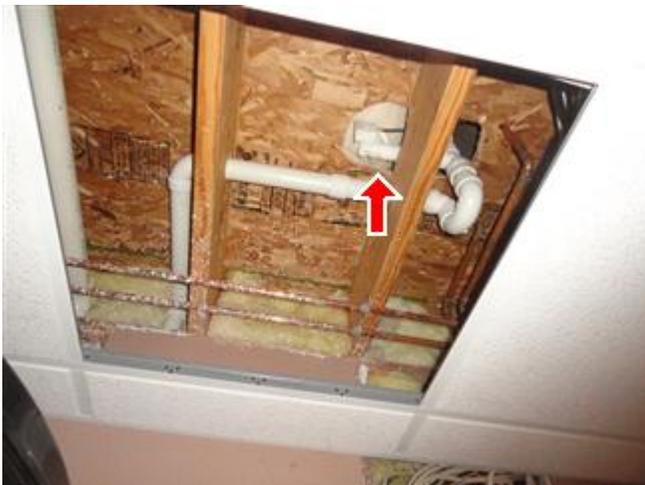
Most of these leaks may have been repaired. Drain line leaks are slow to develop and typically only become visible after continuous use over an extended period of time. The only active leak on the day of this inspection was a drain leak under the hydro-tub. I recommend you monitor these areas to determine which ones may still be active. This is a maintenance issue for your consideration.

13.0 Picture 27 - Water stained tile from hydro tub drain leak (active)

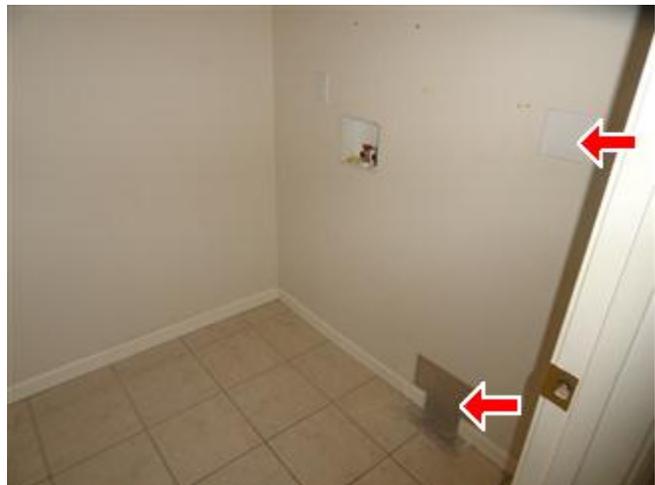
The upper floor laundry room is not currently useable. The power for the dryer has been disconnected and the dryer vent has been removed. Currently the laundry room in the basement is the only one in operable condition. **(See Picture 28, appendix A)**

13.0 Picture 28 - 1st floor laundry disconnected

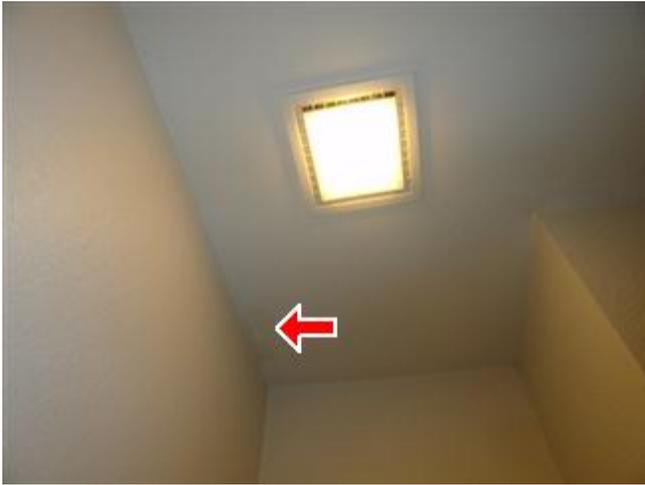
(2) There were two ceiling stains found on the upper floor, one in each bathroom. They are both associated with the same roof leak due to a failed sewer vent boot discussed in Section 5.2 of this report. **(See Picture 29, Appendix A)**

13.0 Picture 29 - Water stain master bath ceiling

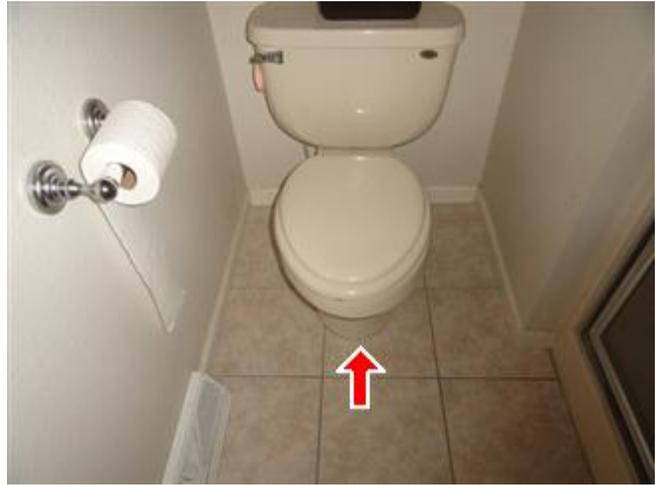
(1) The toilet in the master bathroom is not properly secured to the floor. I recommend a qualified plumber make the necessary repairs. **(See Picture 30, Appendix A)**

13.0 Picture 30 - Master bath toilet not secured to floor

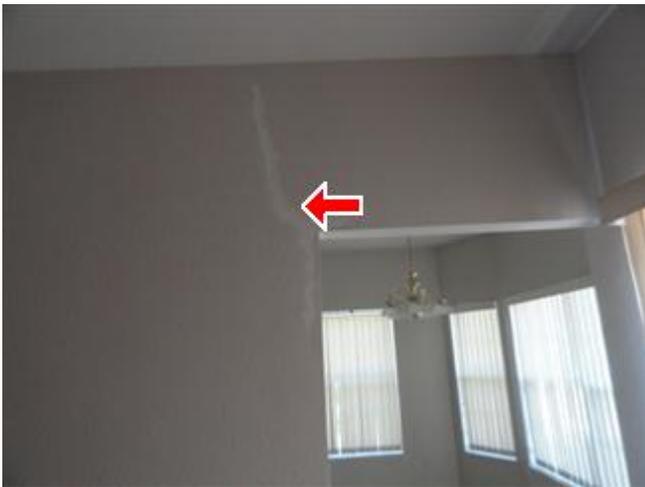
(1) A few small cracks were visible in the wall separating the kitchen from the living room, which has been repaired but not painted. This crack is most likely associated with some floor movement, however a more detailed structural investigation would be needed to isolate the exact cause. **(See Picture 31, Appendix A)**

13.0 Picture 31 - Wall crack at dining room

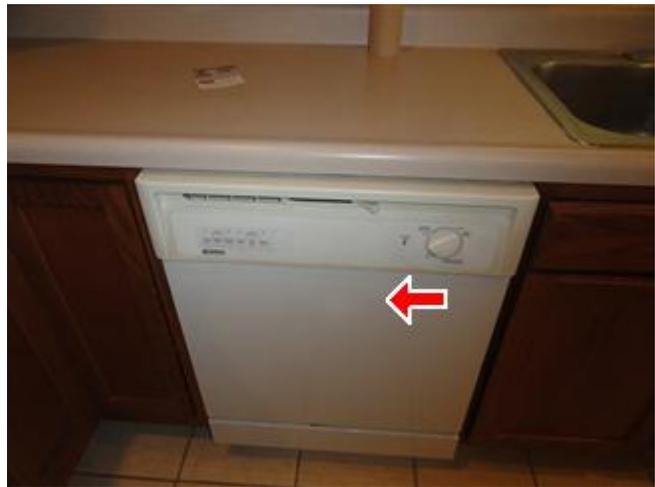
The dishwasher was not fully operation at the time of this inspection. I recommend having this unit serviced or replaced. **(See Picture 32, Appendix A)**

13.0 Picture 32 - Dishwasher not operational

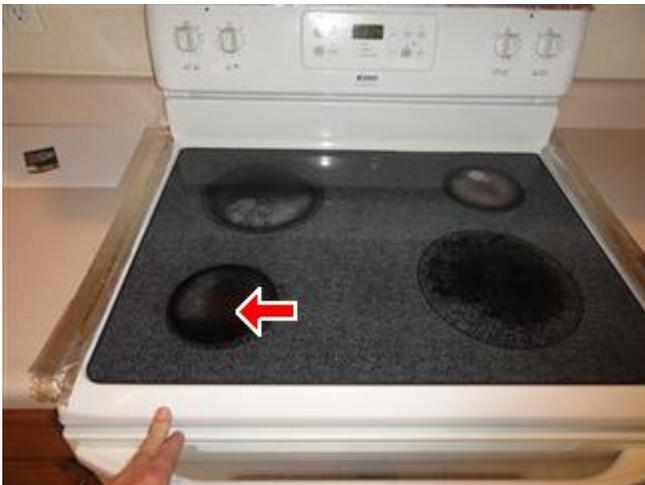
The stove was functional except for the left front burner. I recommend having this unit serviced or replaced. **(See Picture 33, Appendix A)**

13.0 Picture 33 - Left front burner does not work

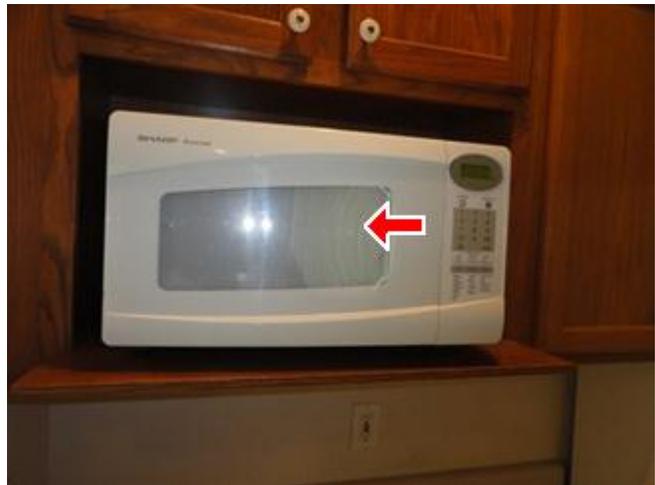
13.0 Picture 34 - Microwave would not respond to control buttons

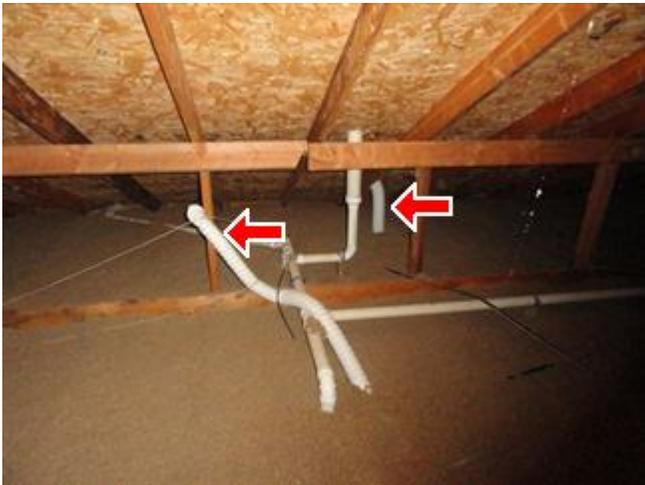
13.0 Picture 37 - Bathrooms vent into the attic

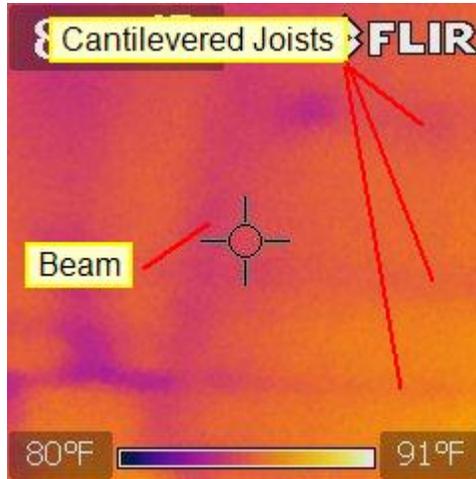
(1) There were some variations in floor elevations with noticeable humps in some rooms associated with cantilevered floor joists. From observations made the cantilevered joists in the dining room/kitchen area were built by extending the original floor joists, as shown in the left diagram below. This is the most preferred method because of the simplicity and cantilevered forces are distributed better into the house. The floor joists over the garage were oriented perpendicular to the other floor joists in the house, which required framing cantilevered joists for the two front bedrooms using the method shown on the right diagram below. This method is the least desirable because the cantilevered forces are carried by one beam at the end. The garage ceiling was covered with drywall making direct observation of the floor joist details impossible without cutting a hole in the drywall. For verification of the orientation and configuration of the cantilevered joists an infrared camera was used. The infrared camera indicated the cantilevered joists do not meet the 3:1 minimum requirements required by acceptable building practices. **(See Picture 38, Appendix A)**

These shorter joists create larger uplift forces which caused the noticeable hump in the two bedroom floors. Providing support under the extended cantilevered rooms on the outside would be the most cost effective solution. Addition blocking over the support walls was also missing from the visible cantilevered areas under the dining and kitchen areas and may be missing from bedroom cantilevered framing as well. There are two factors that need to be considered; one is the long term deflection or creep associated with constant load of the house on the cantilevered floor joists and beam, second is the method used to connect the cantilevered floor joist to the supporting beam. The deflection associated with long term creep will increase over time and can reasonably be expected surpass the initial deflection, when the house was built, by a factor of two. I recommend further investigation of the connection details, requiring cutting holes in the garage ceiling drywall, if no external support is provided at the bedrooms.

13.0 Picture 38 - Infrared photo of cantilevered joists

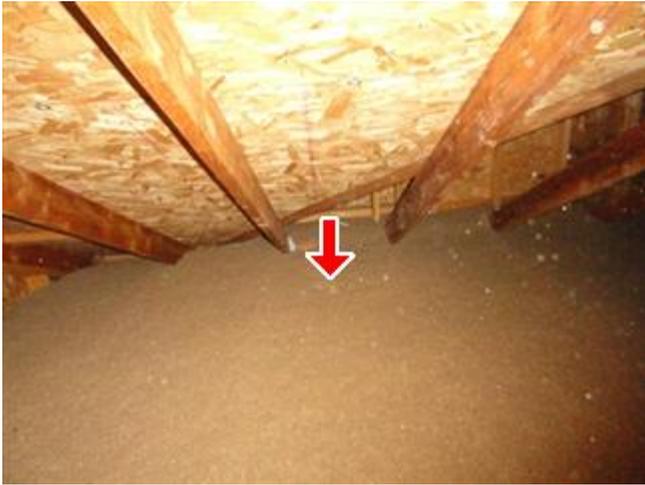
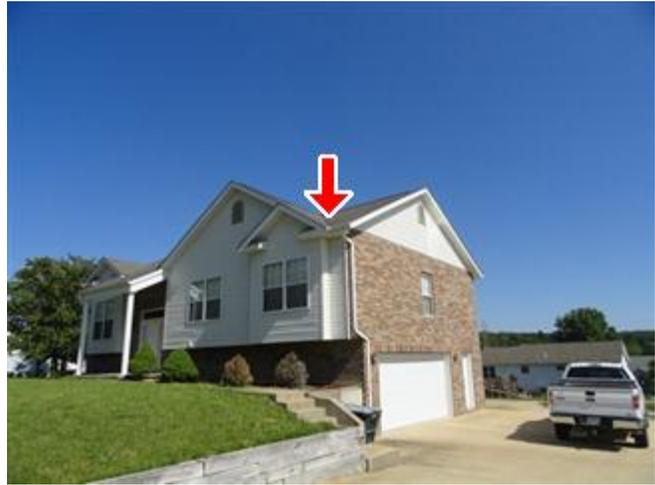
The roofing material appeared to be in satisfactory condition relative to its age. However there was one small area under a valley where water had leaked in the past. I recommend a qualified roofer investigate and correct as needed. **(See Pictures 39, 40, Appendix A)**

13.0 Picture 39 - Evidence of past leak at valley

13.0 Picture 40 - Location where roof had leaked
