Report Prepared For:

**Property Address:**xxxx Old St. James Road
Rolla, MO 65401**INSPECTION CERTIFICATION**

GENERAL INFORMATION

xxxx Old St. James Road
 Rolla MO 65401

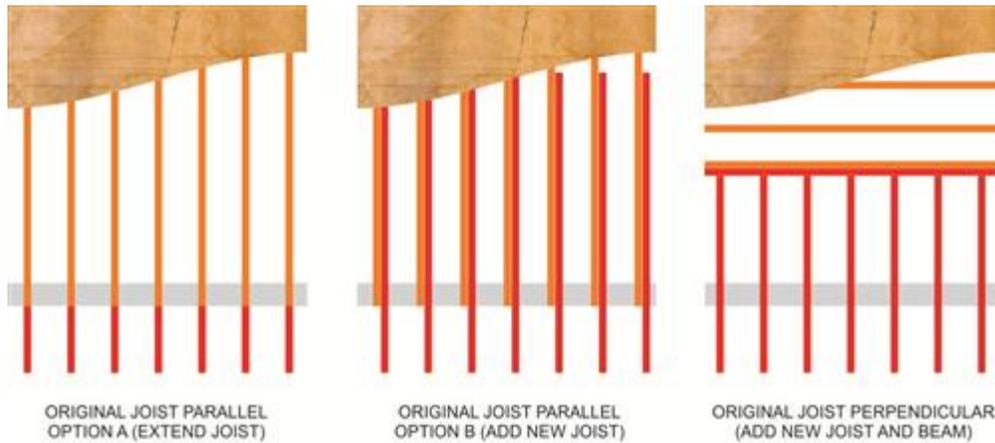
4.2 Picture 1

(1) There were some variations in floor elevations with noticeable humps in some rooms associated with cantilevered floor joists. From observations made the cantilevered joists in the dining room/kitchen area were built by extending the original floor joists, as shown in the left diagram below. This is the most preferred method because of the simplicity and cantilevered forces are distributed better into the house. The floor joists over the garage were oriented perpendicular to the other floor joists in the house, which required framing cantilevered joists for the two front bedrooms using the method shown on the right diagram below. This method is the least desirable because the cantilevered forces are carried by one beam at the end. The garage ceiling was covered with drywall making direct observation of the floor joist details impossible without cutting a hole in the drywall. For verification of the orientation and configuration of the cantilevered joists an infrared camera was used. The infrared camera indicated the cantilevered joists do not meet the 3:1 minimum requirements required by acceptable building practices. **(See Picture 38, Appendix A)**

These shorter joists create larger uplift forces which caused the noticeable hump in the two bedroom floors. Providing support under the extended cantilevered rooms on the outside would be the most cost effective solution. Addition blocking over the support walls was also missing from the visible cantilevered areas under the dining and kitchen areas and may be missing from bedroom cantilevered framing as well. There are two factors that need to be considered; one is the long term deflection or creep associated with constant load of the house on the cantilevered floor joists and beam, second is the method used to connect the cantilevered floor joist to the supporting beam. The deflection associated with long term creep will increase over time and can reasonably be expected surpass the initial deflection, when the house was built, by a factor of two. I recommend further investigation of the connection details, requiring cutting holes in the garage ceiling drywall, if no external support is provided at the bedrooms.

TYPICAL CANTILEVERED FLOOR CONSTRUCTION METHODS

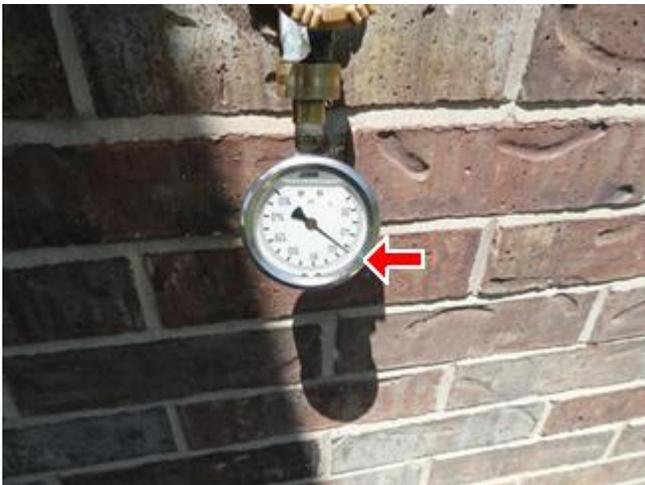
The internal water pressure measured at the rear of home was 52 psi at the time of the inspection, which is within the normal range. **(See Picture 9, Appendix A)**

13.0 Picture 9 - Water pressure 52 psi

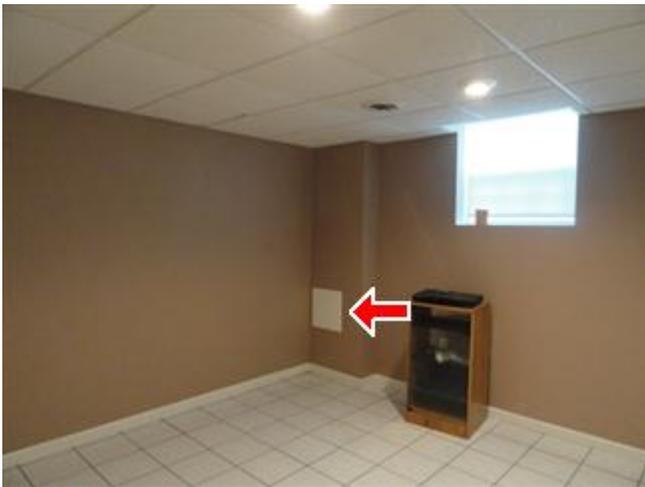
The main shut off is located inside the basement wall behind the white plastic door. **(See Picture 41, Appendix A)**

13.0 Picture 41 - Location of main water shut-off
